Smart Energy Design Assistance Center

SEDAC CASE STUDY 06-1, November 2006

PERCEPTIVE VISIONS

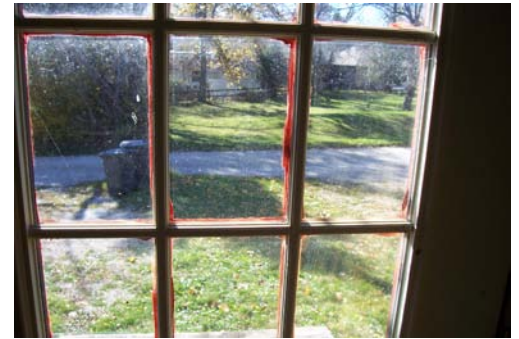
existing window example

They replaced the single pane windows with low-e, well-sealed, double pane, non-metallic sashed windows having a U-value less than 0.4. Also installed was a thick and sturdy, high-density, cross-laminated polyethylene vapor barrier over the earthen floor of the crawlspace.

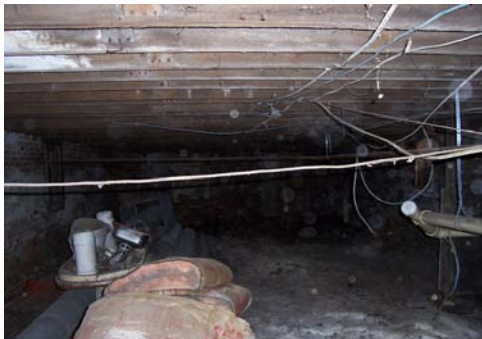
crawl space before retrofit
